ABU 508 service

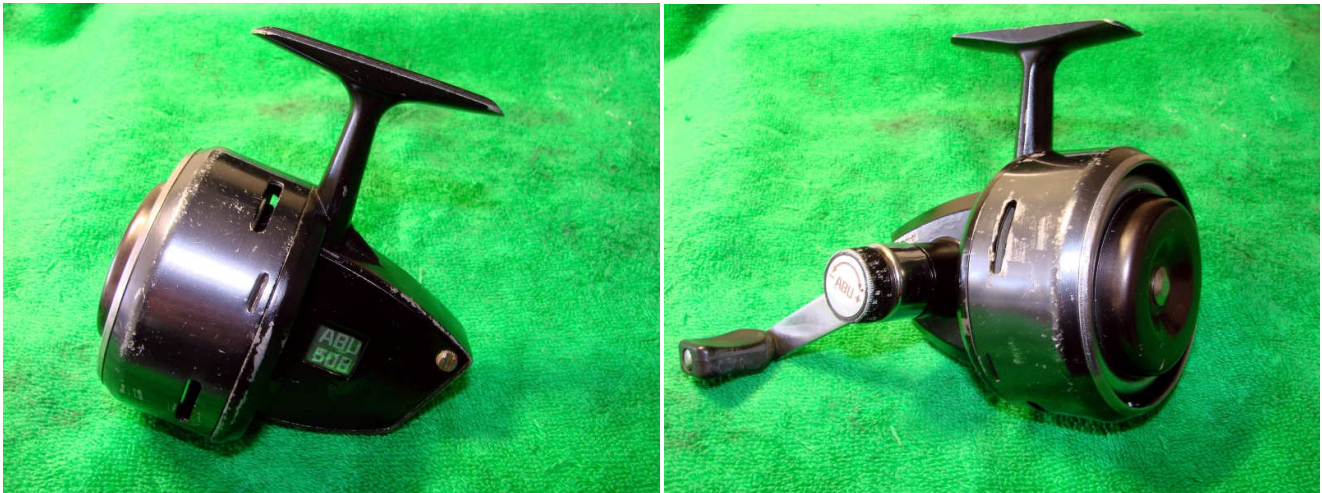
Please refer to the schematic for part #s as I'm not too sure of the part names.

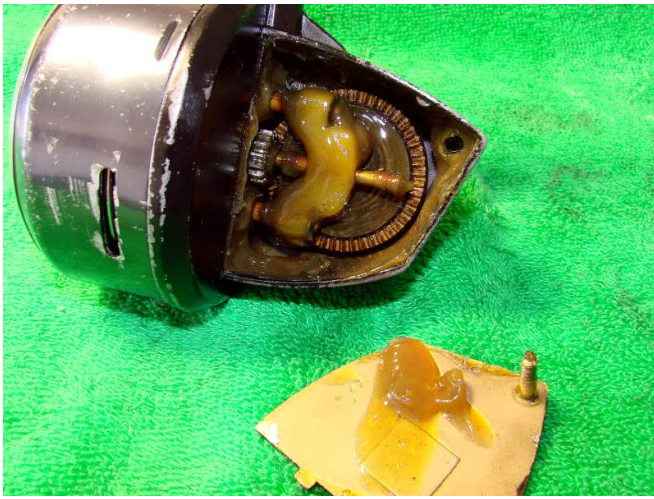
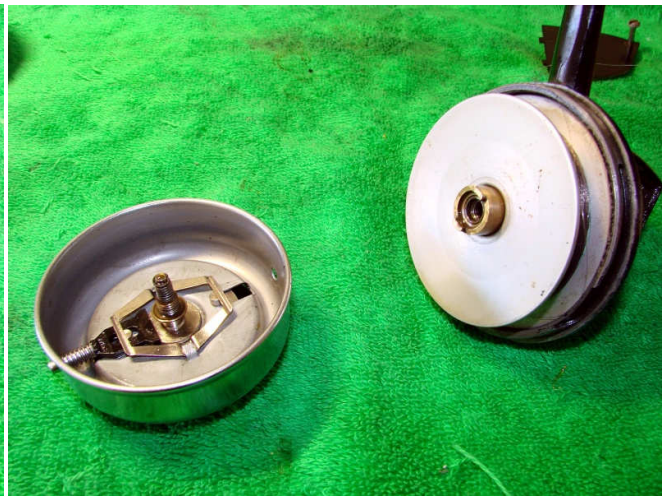
Remove the side plate-just one screw to loosen and no shortage of grease here! Remove the spool cover #9674 (it simply twists off) and unscrew the bell housing #9664. You may need to tighten the drag fully to accomplish this. There is only one pickup pin #9301 although the housing has space for two.

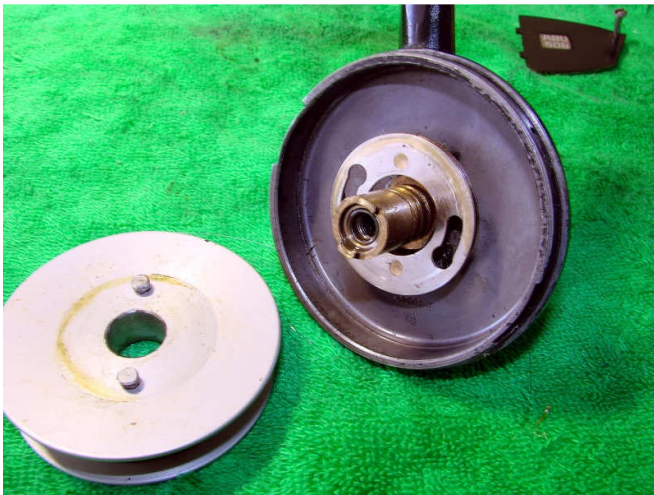
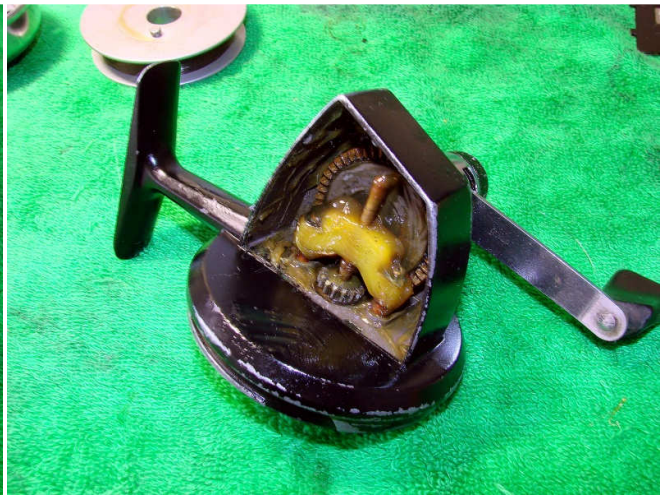
Remove the spool-it has a bayonet mount and you can see the two pins on base of the spool. It's hard to see due to all of the grease but there are two e-clips (#3909) holding on part #9675. Remove these.

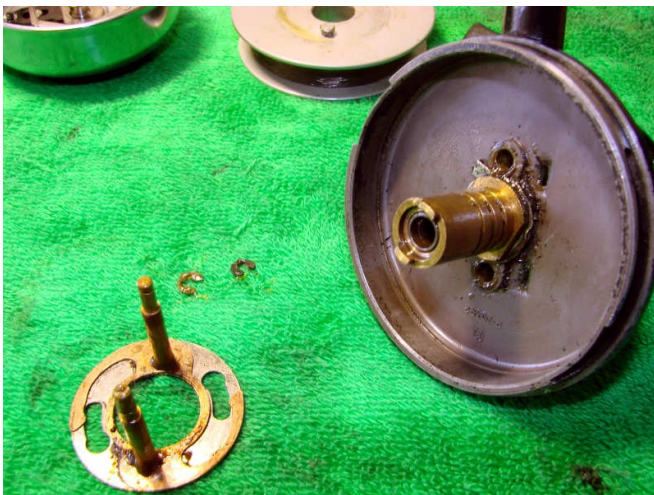
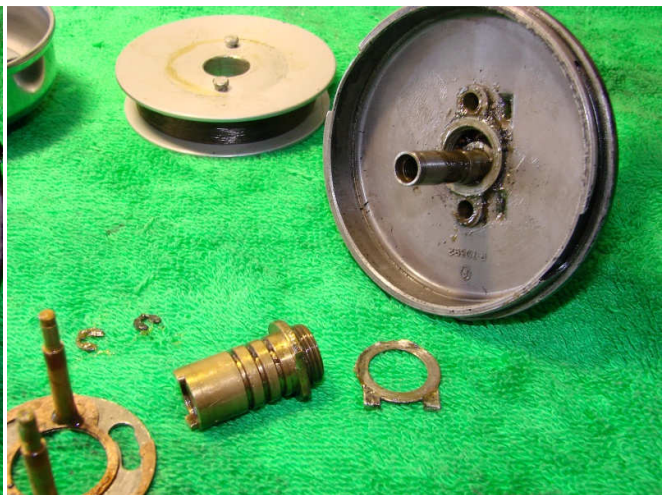
Part #9675 can be removed from the front of the reel body. Unscrew the housing for the pinion gear #9743. Note the locking washer underneath #9742-in this instance it is incorrectly fitted.

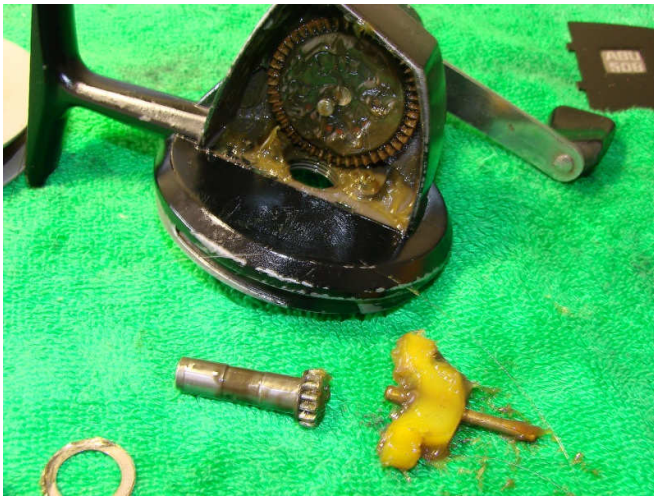
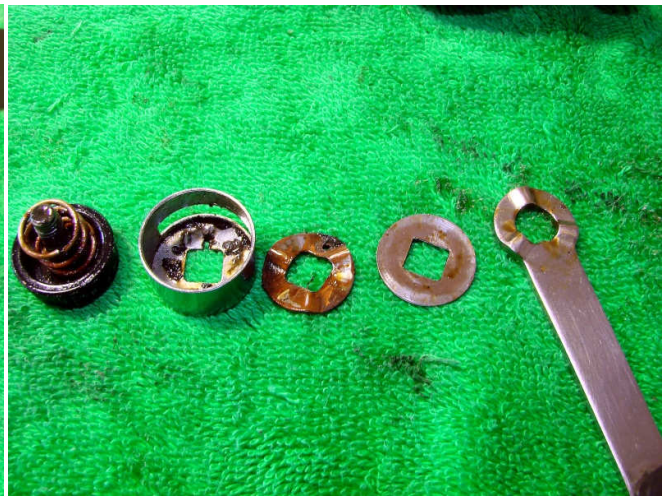
The pinion gear #9671 and the plastic part #5680 can then be removed from the reel body. Note the metal pin in the photo is housed in the plastic part #5680. It should actually be attached to the pinion gear-this is no problem as it can be fixed. Unscrew the drag knob and then remove the handle assembly.

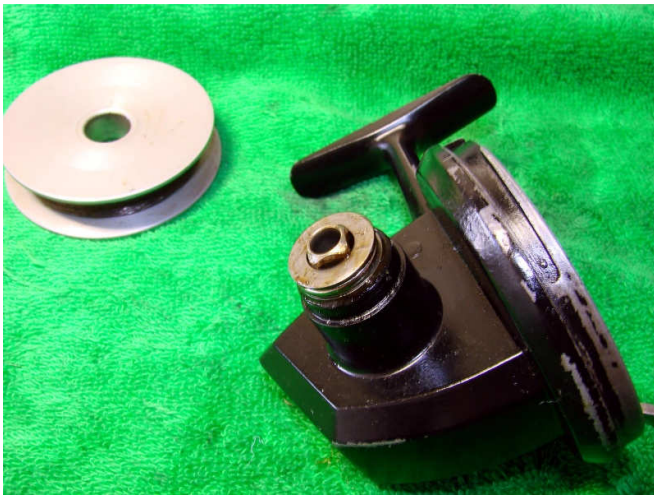
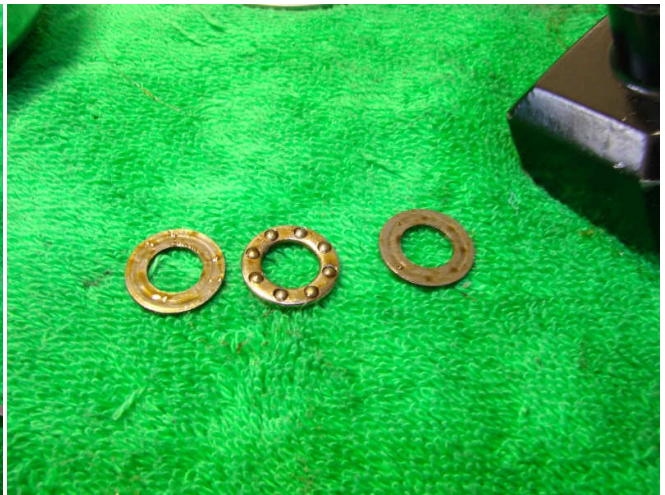
Note there is an open thrust bearing under the handle (# 9011 and #9015).

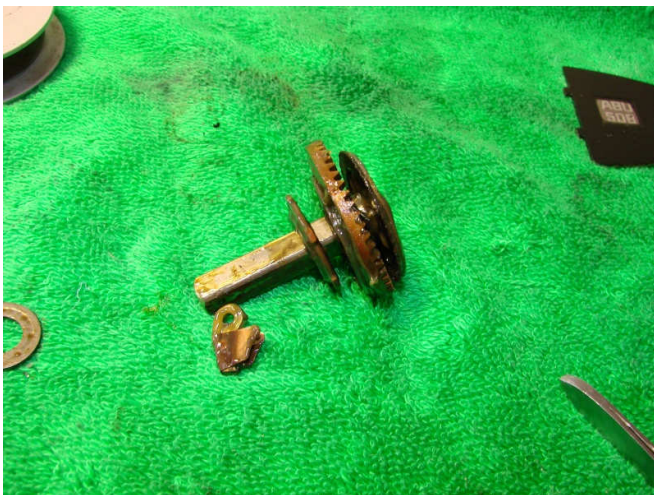
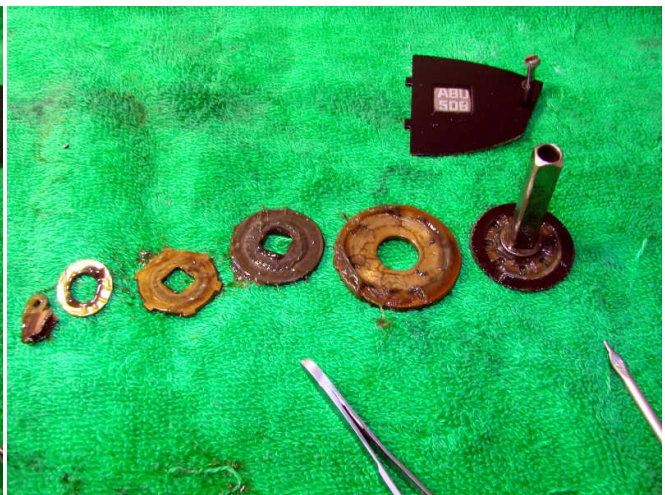
Remove the main gear assembly from the reel body. The anti reverse pawl (#5579) is still present but the copper 'ears' have been bent out of shape-simply bend them back into shape so they grip either side of part #9010-the third part from the left in the second photo.

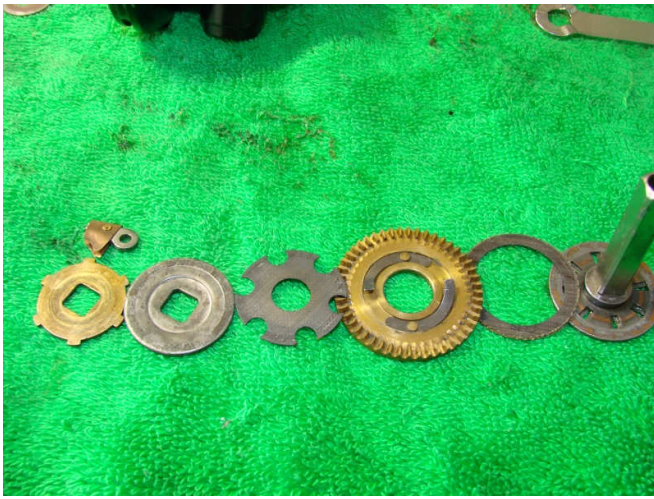
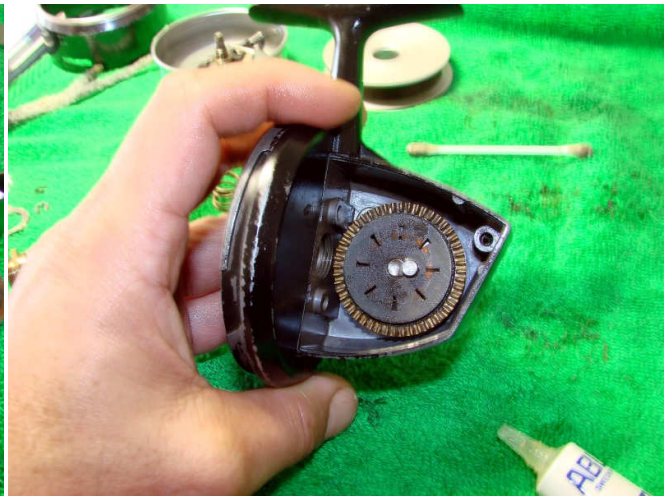
Give everything a thorough clean before reassembly. When reassembling remember not to go mad with grease and oil-excess lubricant just ends up where it shouldn't and attracts dirt and other muck. All friction surfaces/gears need just a light coating. Reassemble the main gear/drag assembly using a light coating of drag grease on the drag washers and where the main gear contacts the main shaft. Attach the anti reverse pawl before placing the assembly in the reel body. Don't forget to oil the outside of the steel bushing in the reel body (#9014).

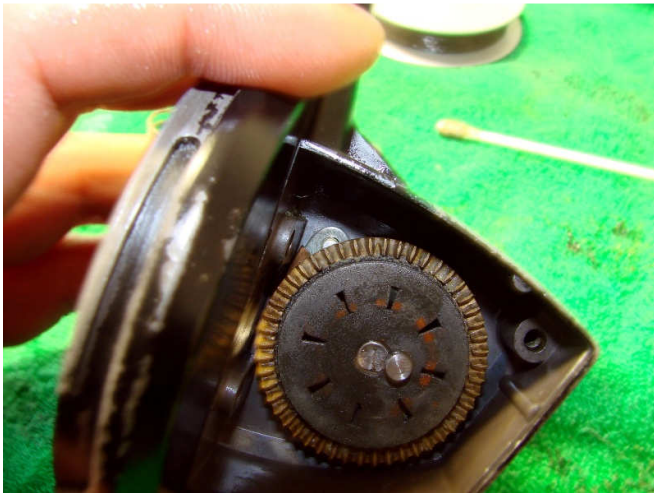
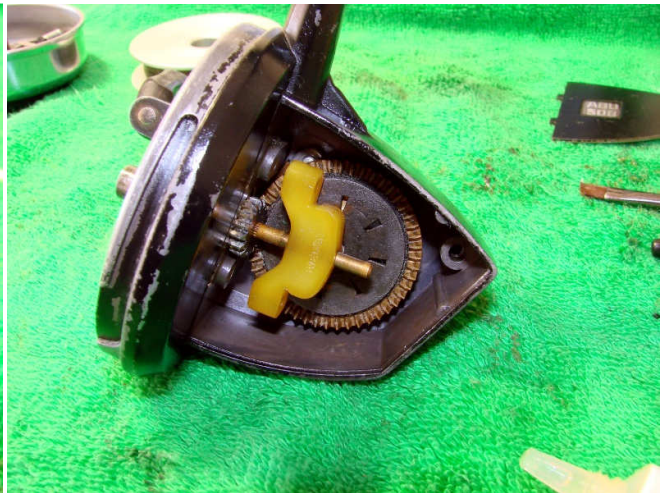
Make sure the anti reverse pawl is correctly seated on its' pin. Replace the pinion gear and plastic oscillating slider.

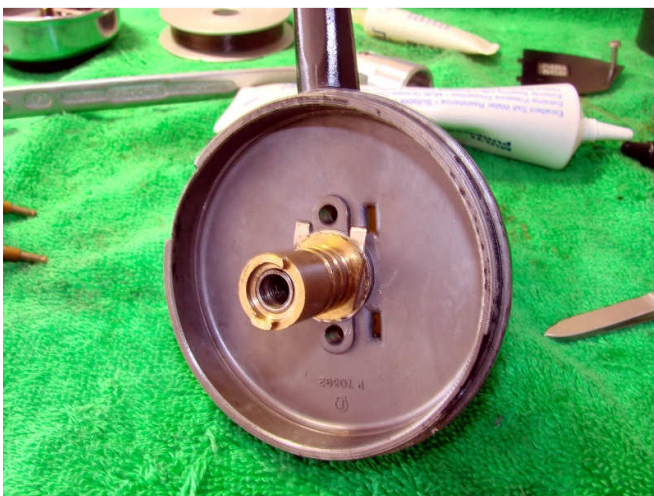
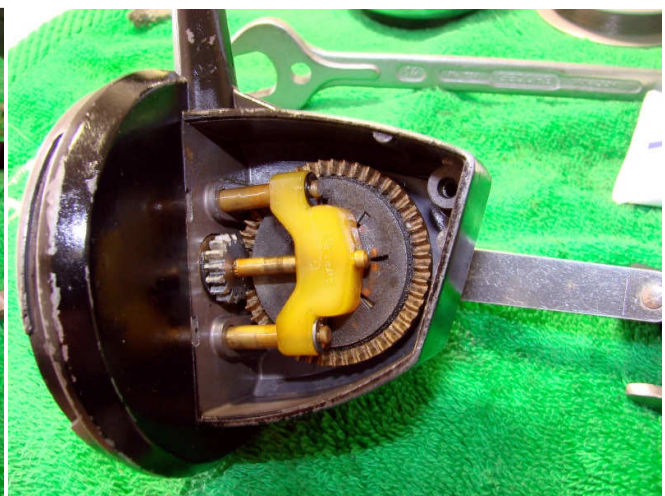
Replace the locking washer and pinion gear housing, not forgetting to oil the shaft of the pinion gear where it contacts the housing. Replace part #9675 and lubricate the pins and fix in place with the two e-clips.

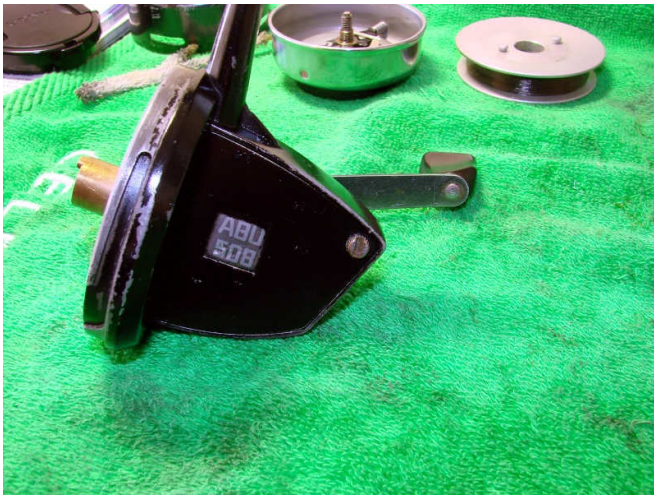
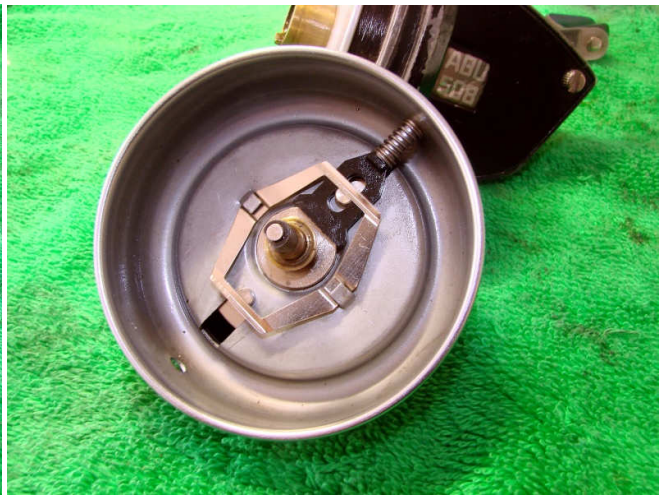
Replace the side plate and the handle assembly not forgetting to grease the thrust bearing. Replace the spool. You will probably need to tighten the drag when you replace the bell housing #9664.

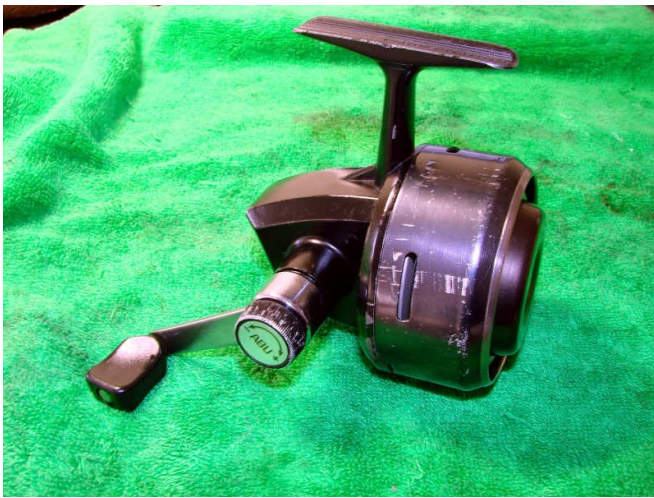
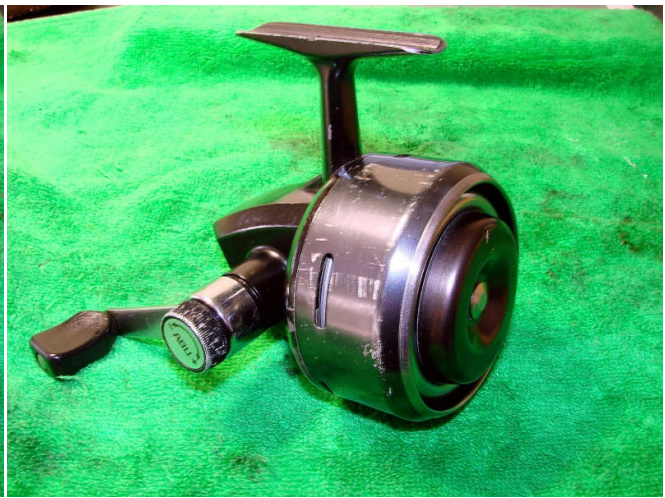
Replace the spool cover and you're finished.
