Ambassadeur 5000 (four screw) service

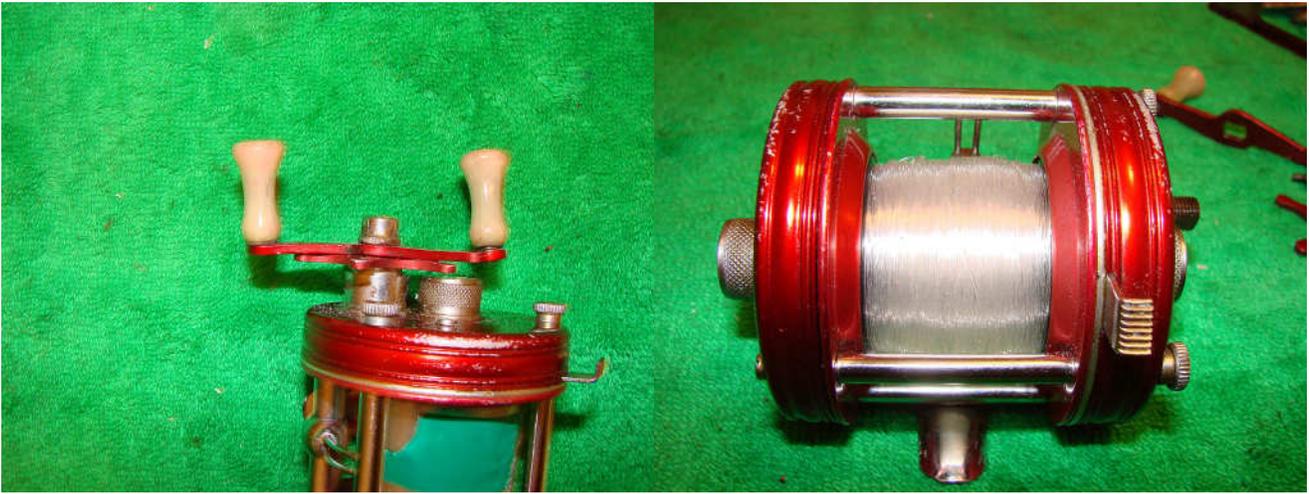
This four screw Ambassadeur 5000 seemed really rough when cranking. The bent handle was obvious but closer inspection showed that the spool didn't quite fit. This was really odd as the spool seemed to be slightly too wide for the frame. Initially I thought that the frame was bent as I also noticed a gap between the left side plate and frame. The colours of the two sideplates on the frame were different so I thought maybe the frame had been repaired at some stage and had been made too narrow by mistake.

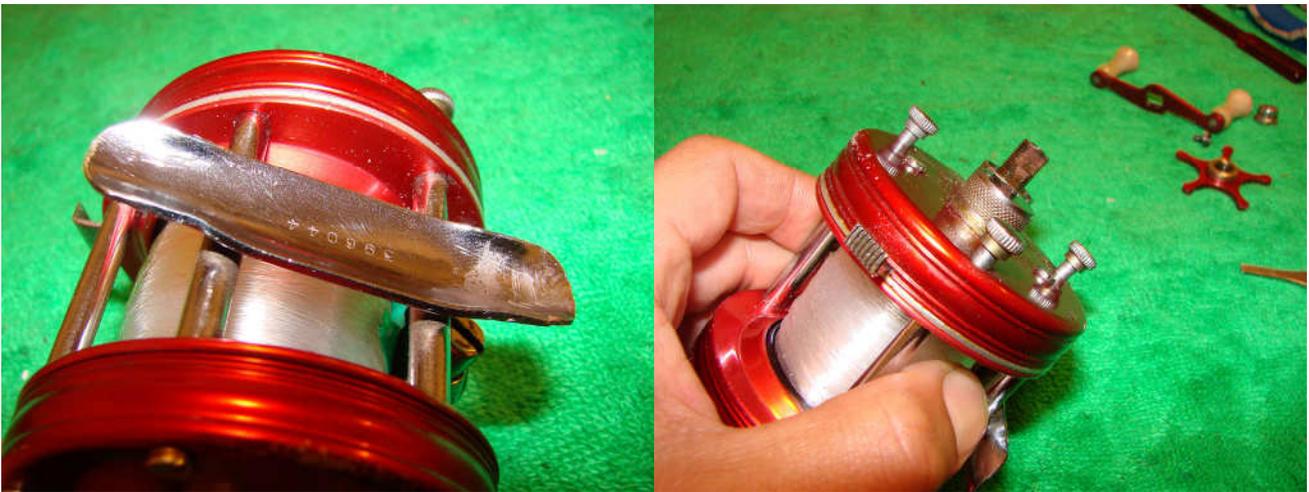
The reel foot looks to have been deliberately bent, possibly to fit a reel seat on a rod? Time to look inside to see what the problem is.

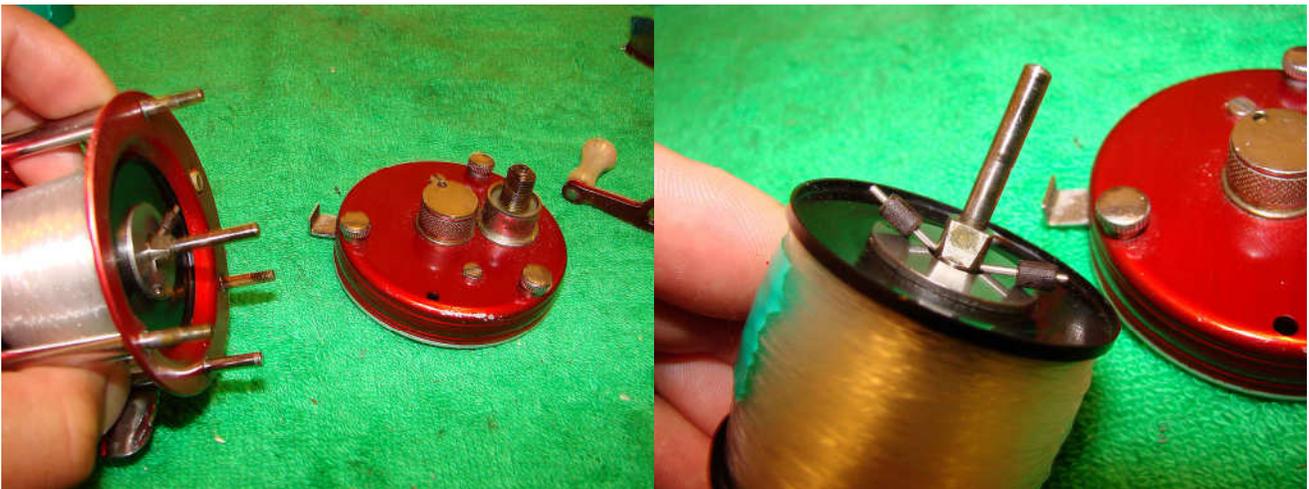
When I removed the right side plate the centrifugal brake pins looked bizarre-like they had been forced upwards.

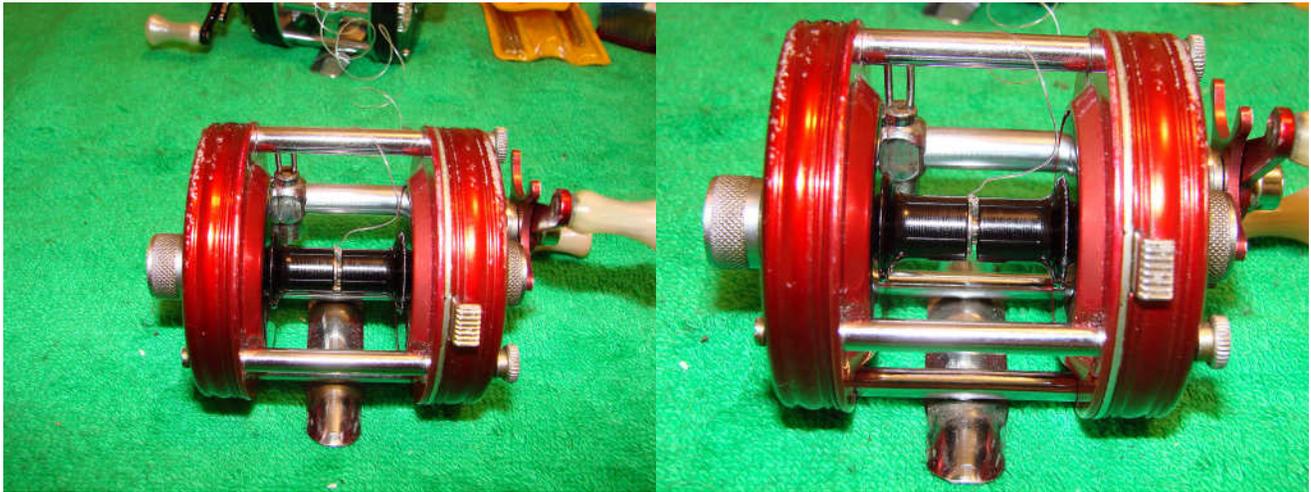
I decided to strip the line off the spool to see if I could find any clues as to what was happening...then I found this. I have never seen anything like it. It looks as if the spool has been forced apart in the middle.

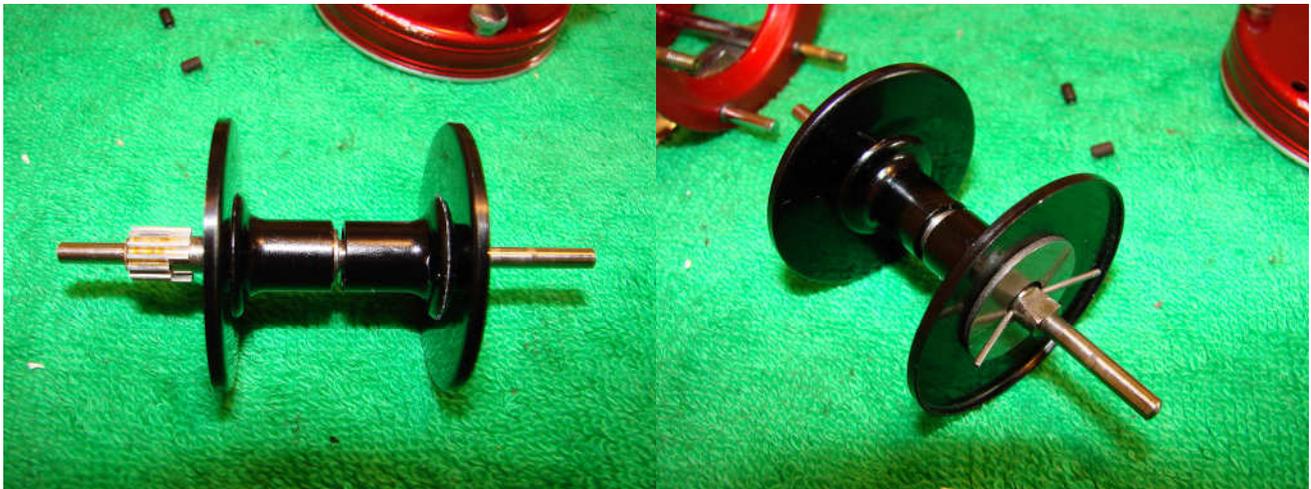
It must have been a huge amount of force to cause the spool to separate and bend the brake pins (judging by the force required to get them back together). I have no idea what could have caused it.

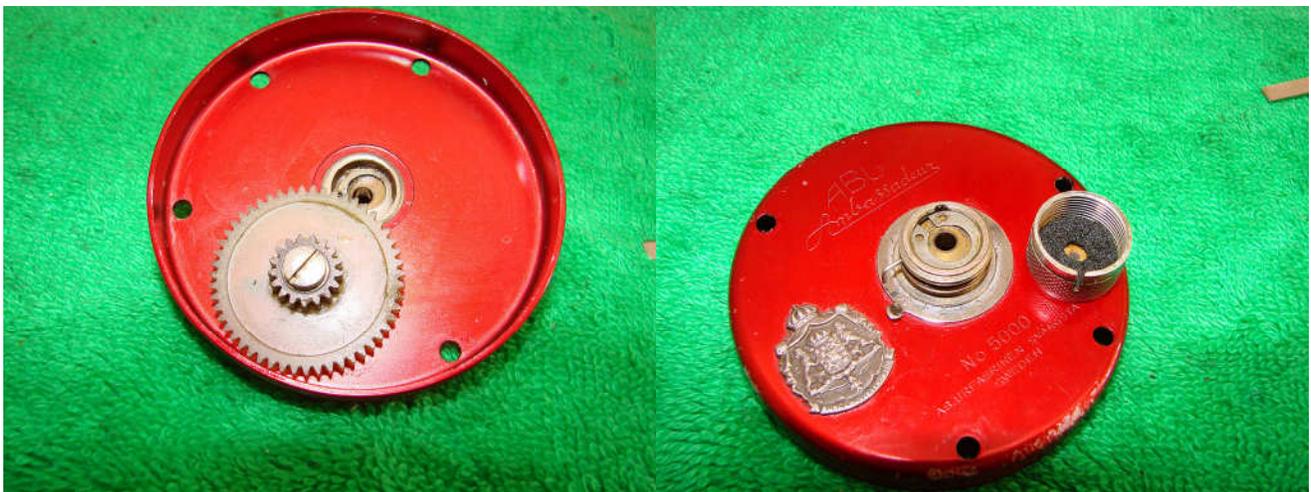
Remove the four pillar screws holding on the left side plate. Remove the idler gear screw and remove the idler gear. Turn the plate over and remove the spool cap.

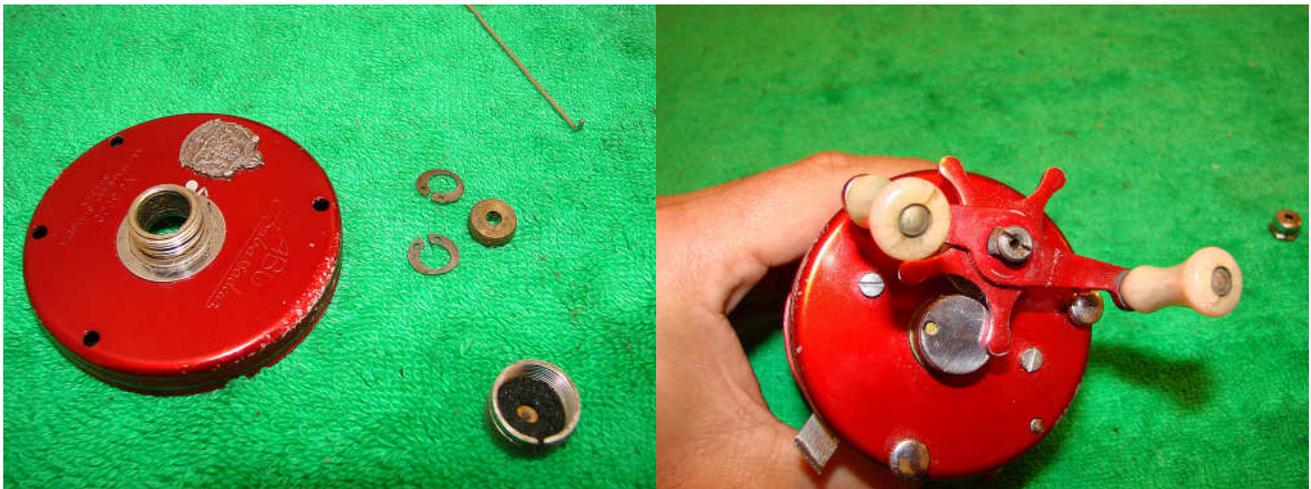
Remove the circlips and the bushing. The felt can be pried out of the spool cap with a tooth pick and the copper shims can be removed. Clean the felt washer by soaking in lighter fuel. Undo the handle nut and remove the screw.

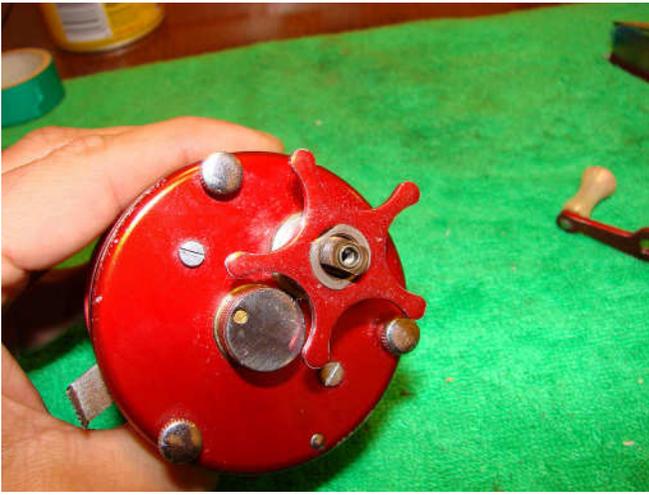
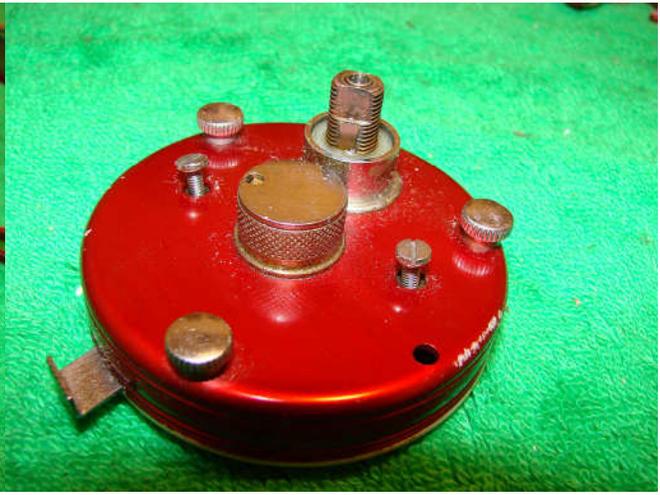
Remove the handle and star drag and then undo the three thumb nuts and remove the side plate from the frame. Undo the two bridge screws and remove the side plate from the brake plate.

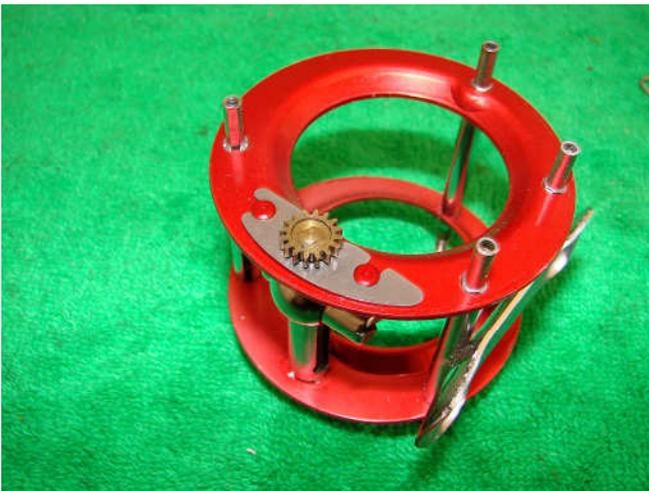
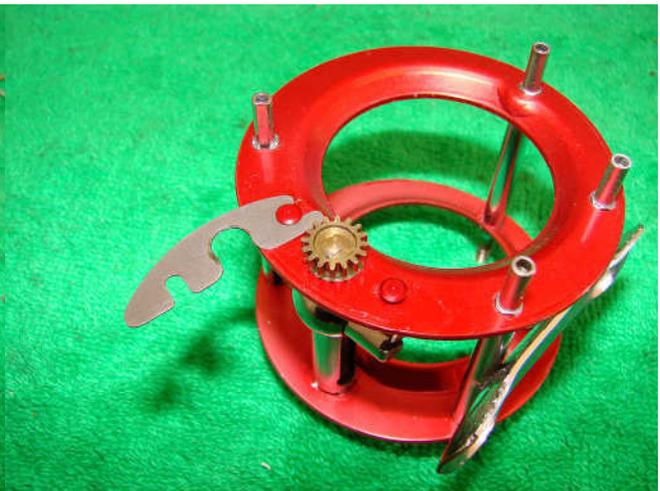
No sign of lubrication though there is no corrosion to speak of. Remove the main gear assembly and the pinion gear for cleaning. You may find it easier to remove the pinion gear if you place the reel in free spool by pressing in the thumb button.

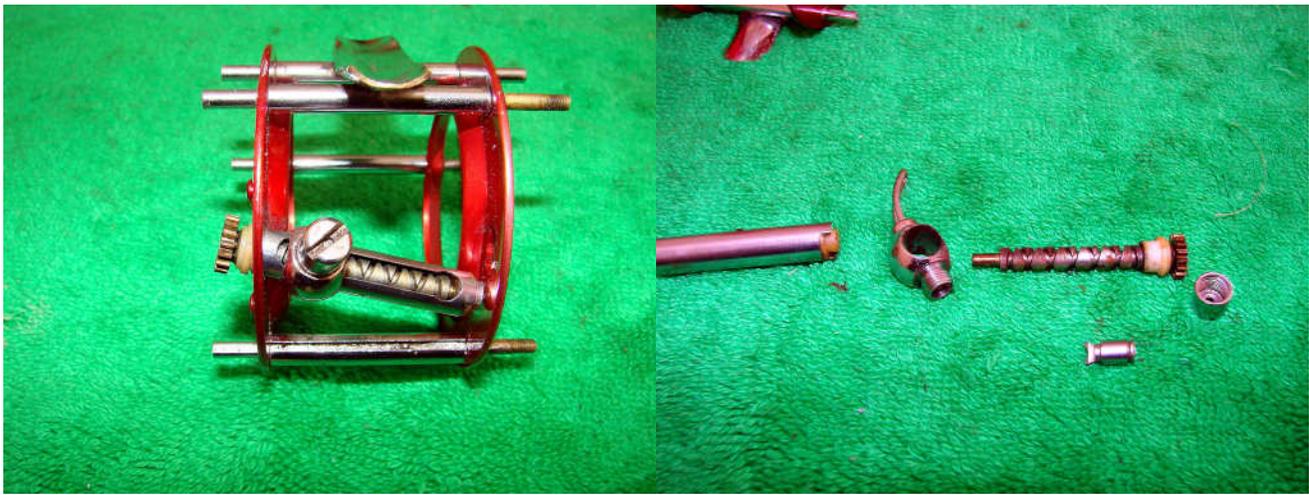
The carriage screw lock is on upside down here! Remove by sliding off.

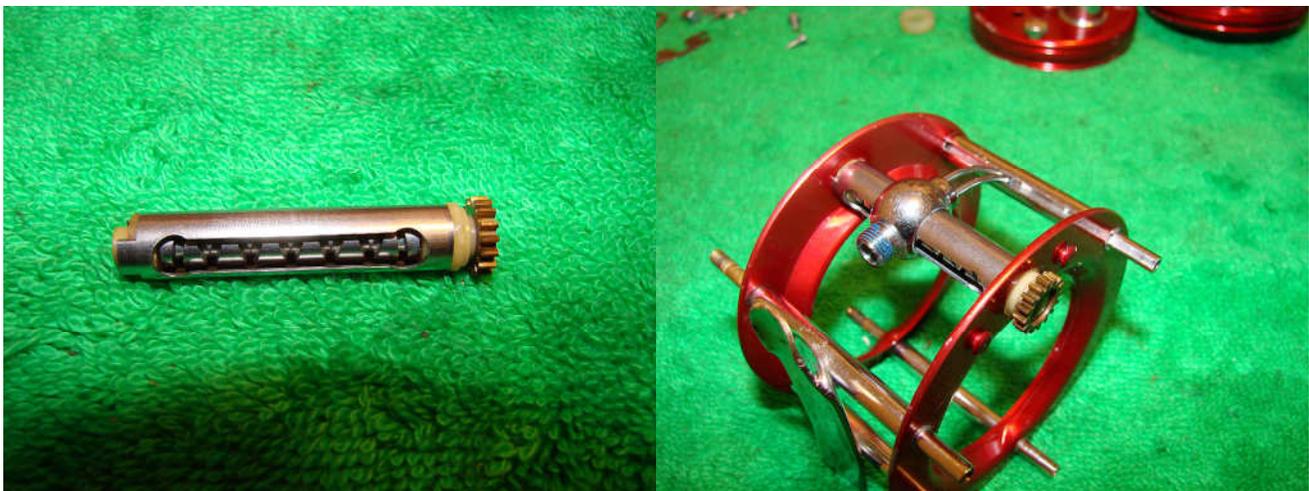
Without the side plates maintaining rigidity this frame shows a bit of flex! Everything needs to be cleaned before reassembly. Washing up liquid, warm water and a toothbrush should get things clean (use lighter fluid for the bushings, centrifugal brakes and the drag washers). If there are stubborn grease and oil deposits you can use lighter fluid/shellite, though I wouldn't recommend using it on plastic parts. Make sure that you rinse and dry all parts thoroughly.

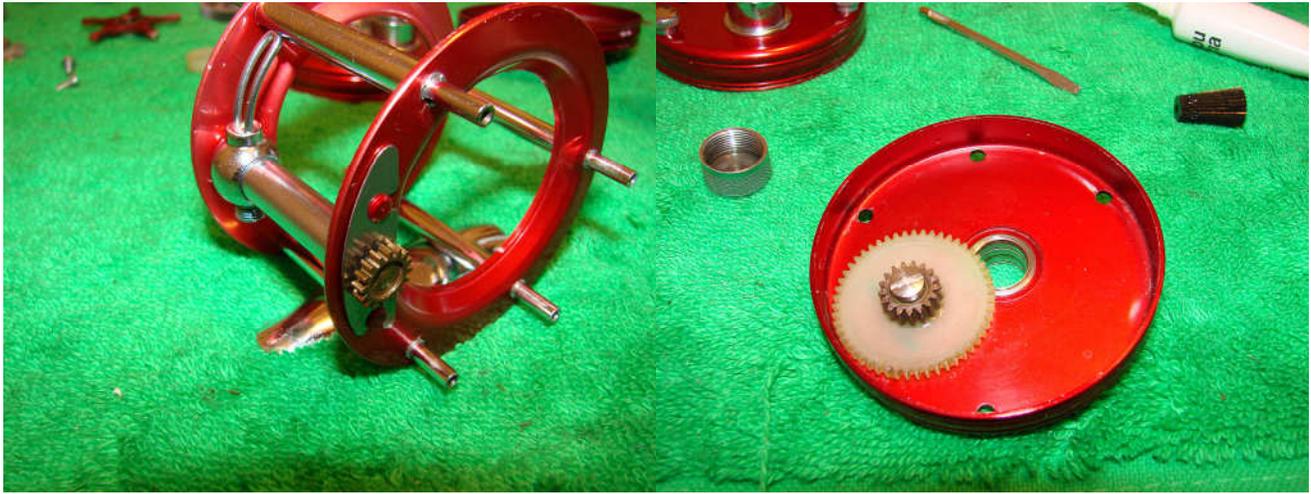
Replace the carriage screw lock, the pawl and the line carriage nut. Add a drop of oil either side of the carriage screw (in the threads). Add a drop of oil to the idler gear post and then replace the idler gear and the retaining screw. Spread liquid grease on the teeth of the idler gear.

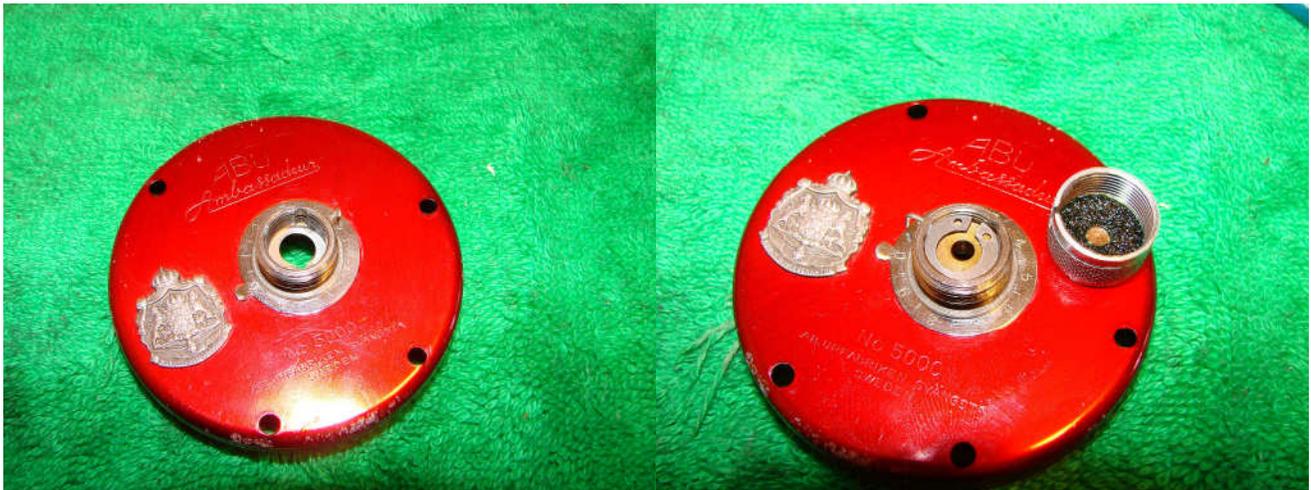
Replace the bottom circlip. Soak the bushing in oil and wipe of any excess and then replace it followed by the top circlip. Replace the shims in the spool cap (with a drop of oil), and then replace the felt washer. Apply oil to the felt washer and then replace the spool cap ensuring that the indicator wire fits properly into the slot.

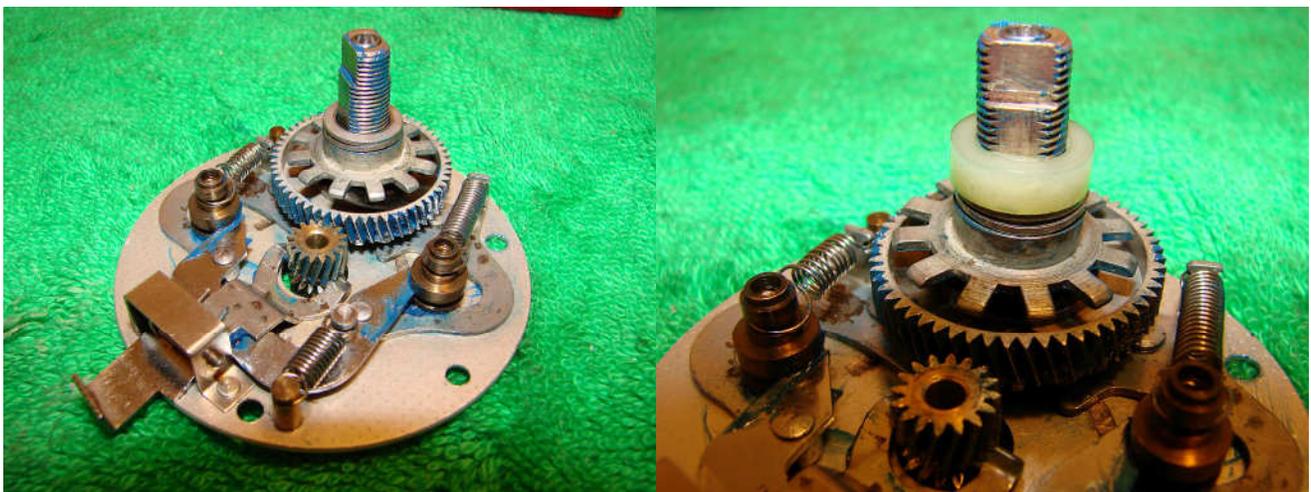
Replace the click wheel and then the curved washer followed by the flat washer and the drive shaft bearing. Smear liquid grease to the outside of the drive shaft bearing.

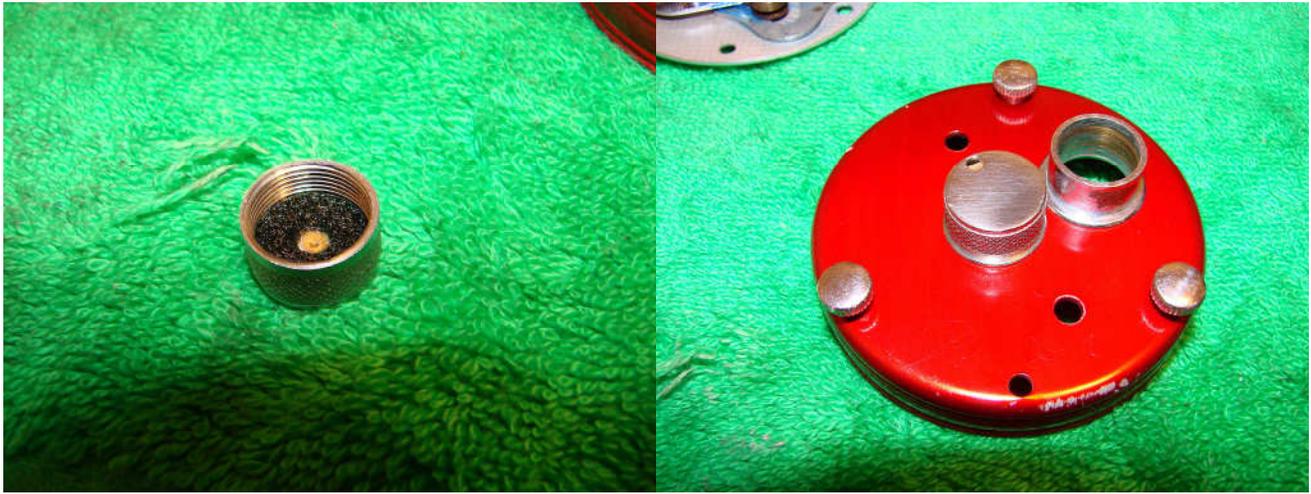
Replace the circlip in the right side plate followed by the bushing (soak in oil first and remove any excess). Replace the copper shims in the spool cap with a drop of oil. Replace the felt washer and saturate it with oil. Grease the threads for the spool cap and replace the spool cap ensuring that it is screwed in fully.

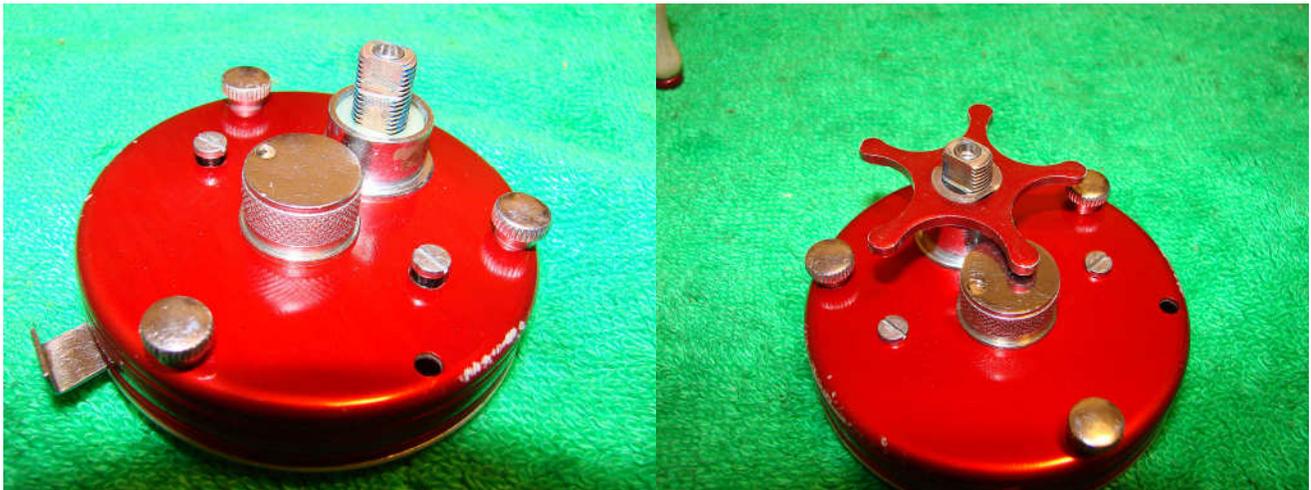
Replace the side plate on the brake plate. Grease the threads on the bridge screws and snug them down. Replace the star drag.

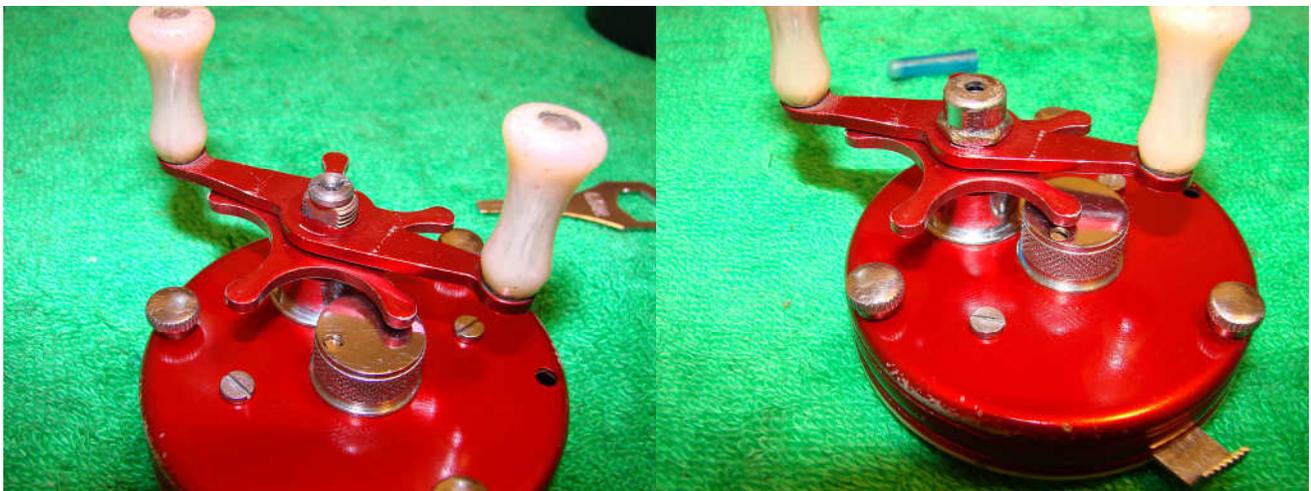
Replace the handle and drive shaft screw followed by the handle nut. Make sure it is snug as there is no handle nut lock on these older Ambassadeurs.
