Record 1000

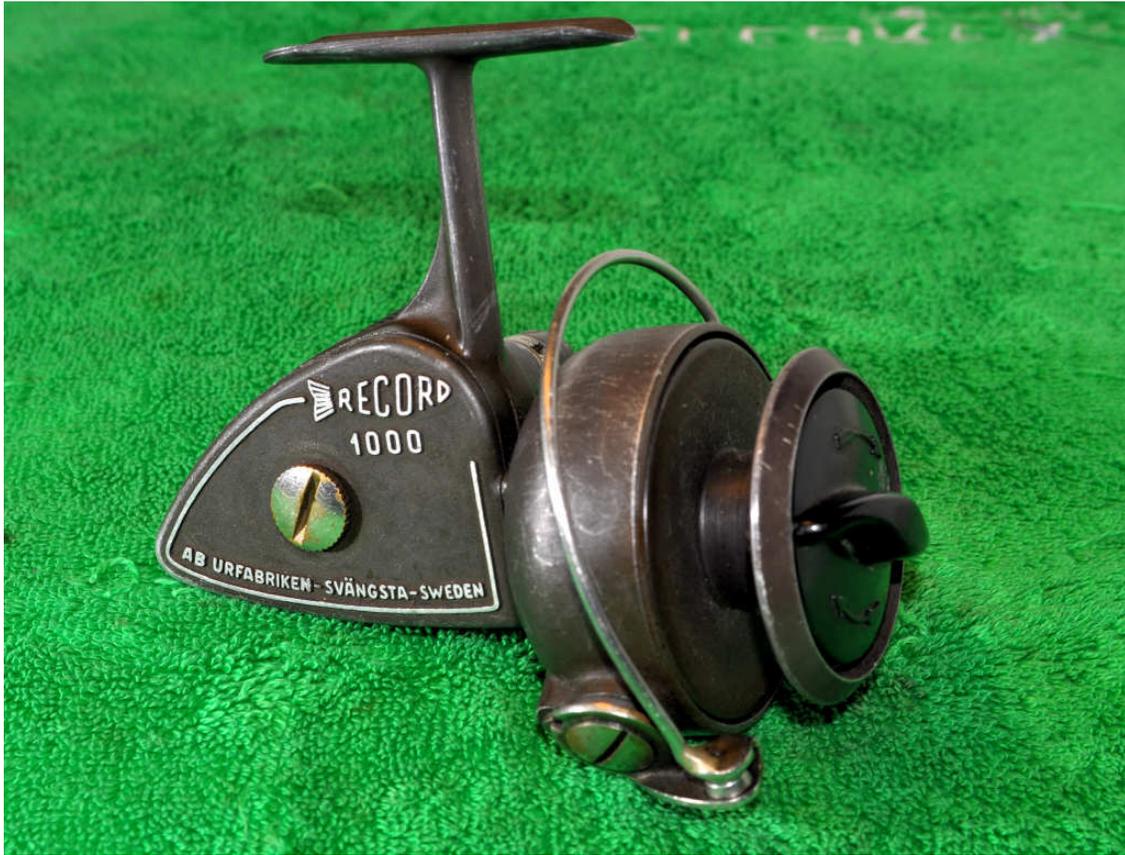
Just a little service guide to show that things don't always go to plan! This reel looks great from the outside and seems to run smoothly with no issues, it is obviously not used for fishing but part of a collection. The left side plate is held in place with just one screw. With this removed a look inside reveals not all is as expected.

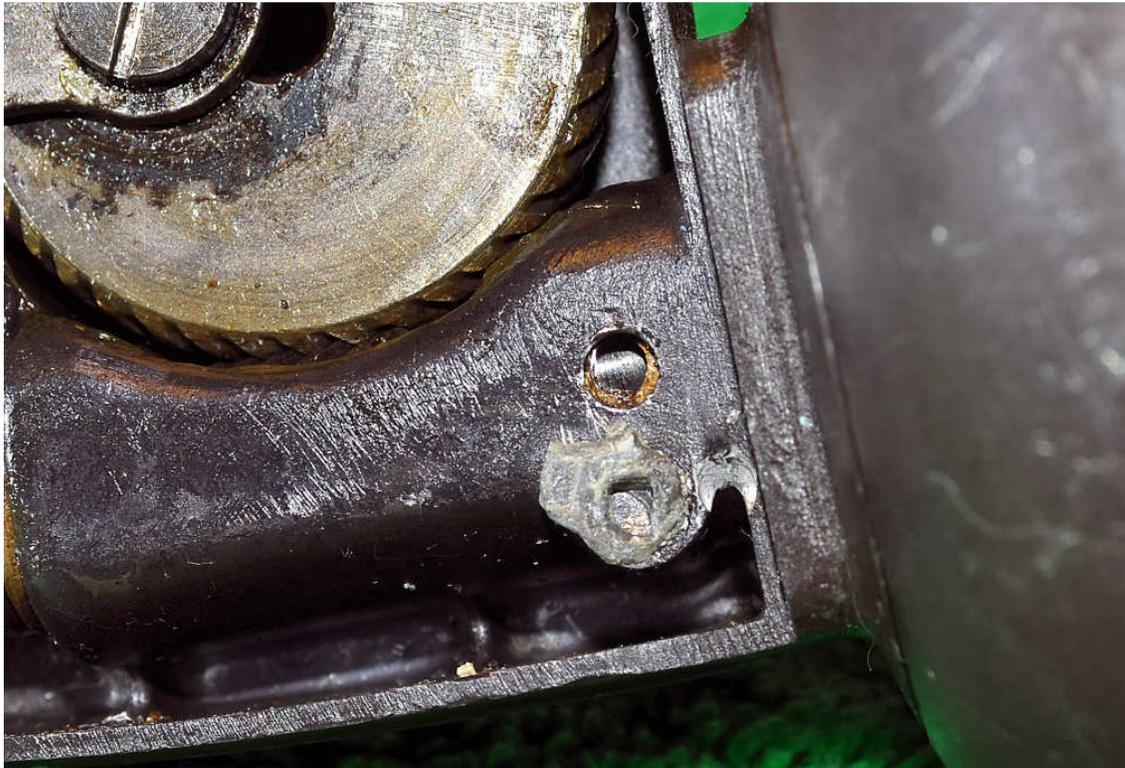
It should be a simple matter of undoing the screws holding the oscillating arm to the main gear and to the end of the main shaft.

However these two screws were 'welded' in place. An overnight soak in penetrating fluid had no effect whatsoever. If this was a working reel you would drill out the screws and replace them. As it is a display reel the screws will be left as is and the reel cleaned and lubricated with light oil/grease.

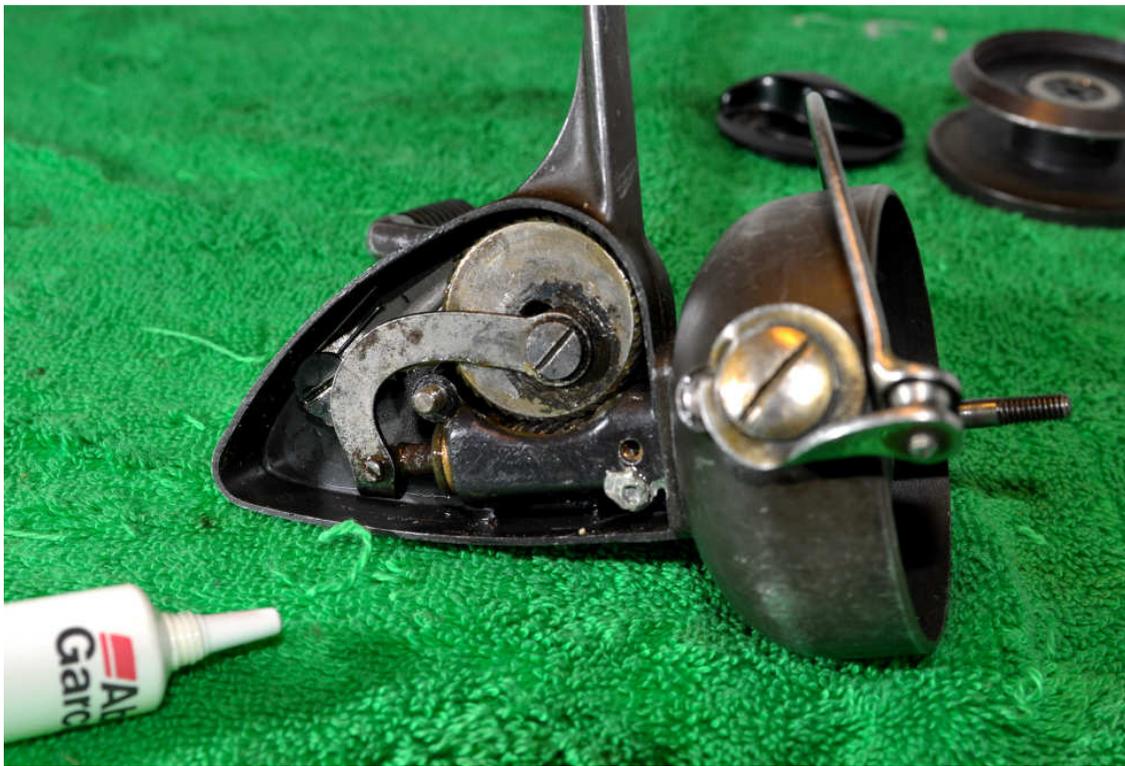
A closer look shows that someone has already tried to drill out a screw and made a bit of a mess. Note the oil port above the mangled screw-use this to lubricate the pinion gear.

Apply a light coat of grease to the gear teeth and where the oscillating arm contacts the main gear, and oil to the main shaft and oil port on the pinion gear casing. Replace the side plate. The reel works fine and as it is an original display reel it is not worth risking further damage, assuming you could get original ABU parts for it.
