Suverän S4000M

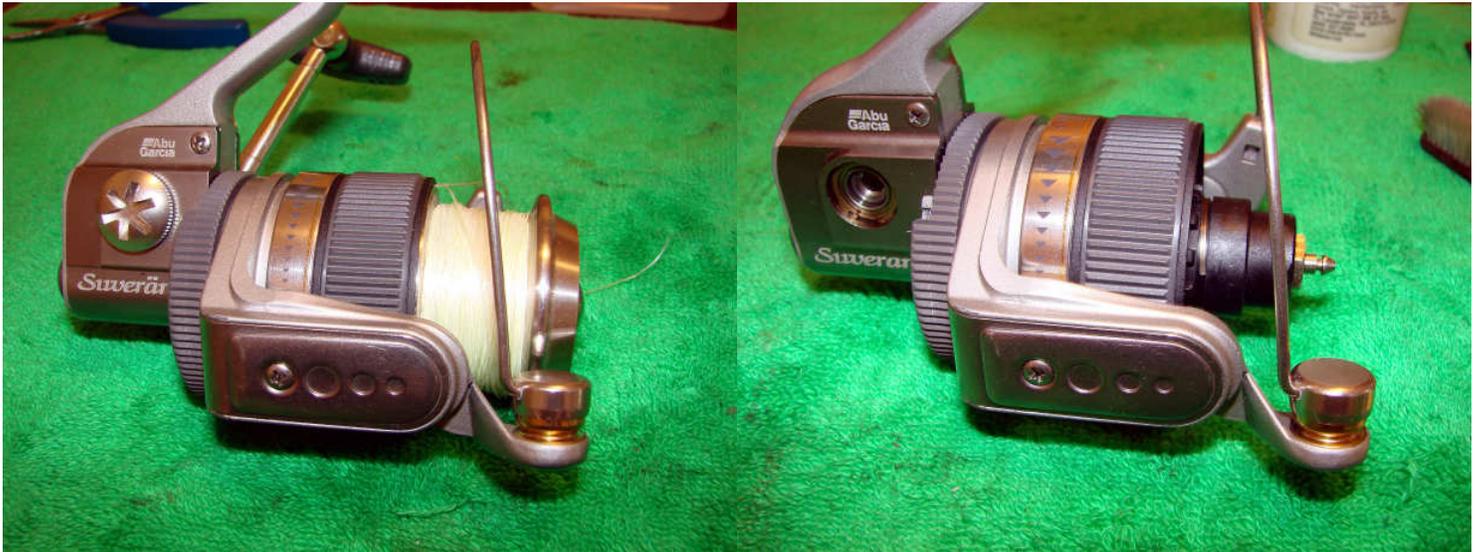
When this Suverän came to me it appeared to have a major problem-the spool did not move in and out when reeling the handle. As line lay is controlled by a worm gear and pawl I suspected that these were damaged. Overall the rest of the reel was in very nice working condition though.

As the reel was being opened up anyway it was given a full service. Start by removing the handle and spool.

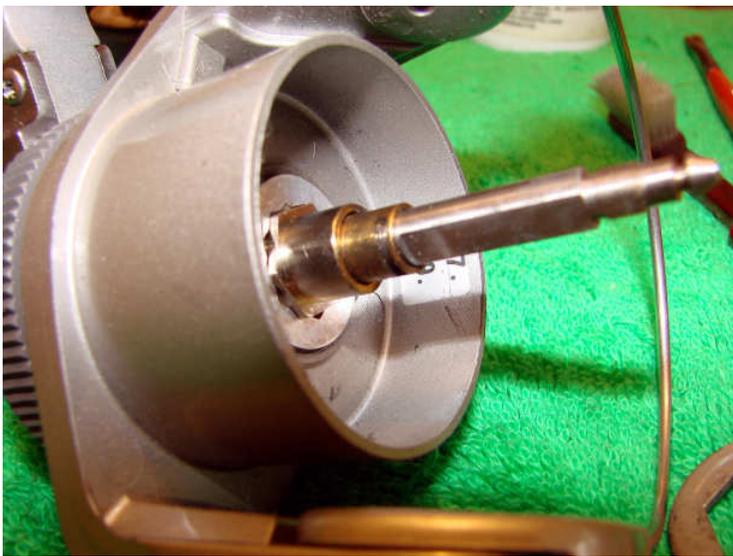
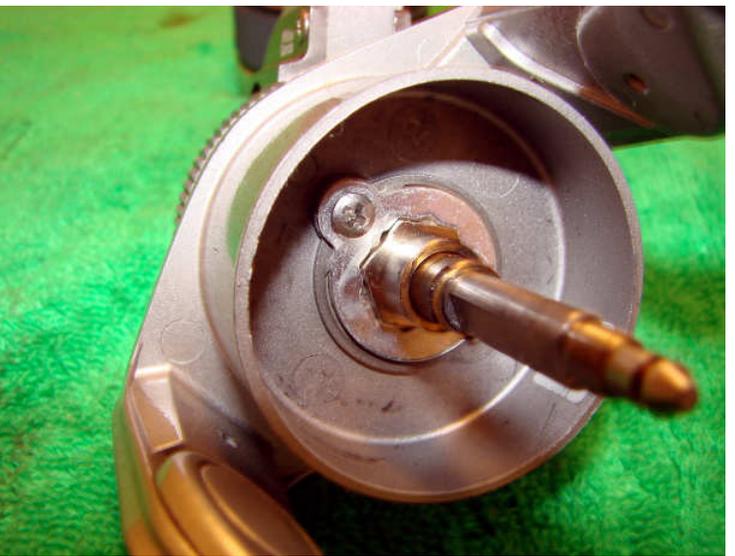
Remove the nut at the end of the main shaft and remove the entire drag system. Put this to one side to be worked on later.

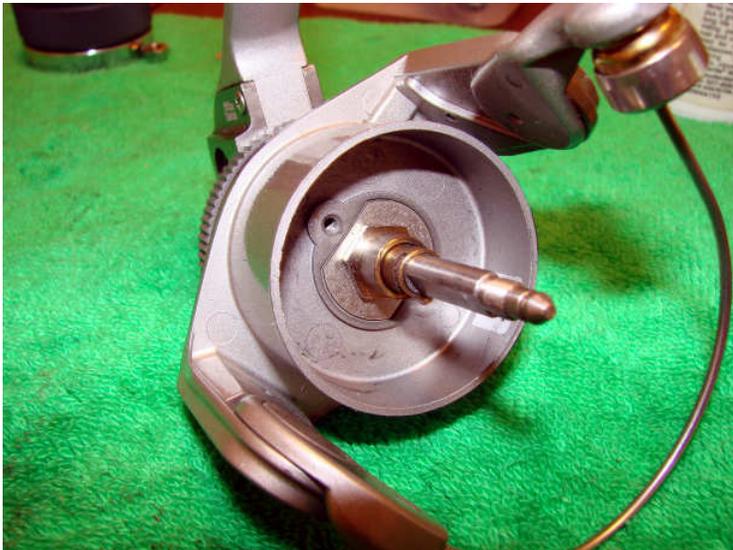
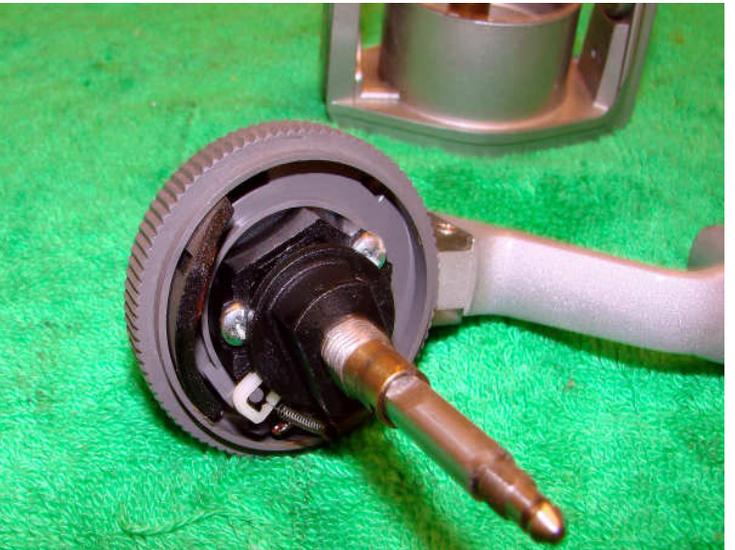
Note there is a rubber o-ring missing. Remove the rotor nut lock plate screw and the rotor nut lock plate.

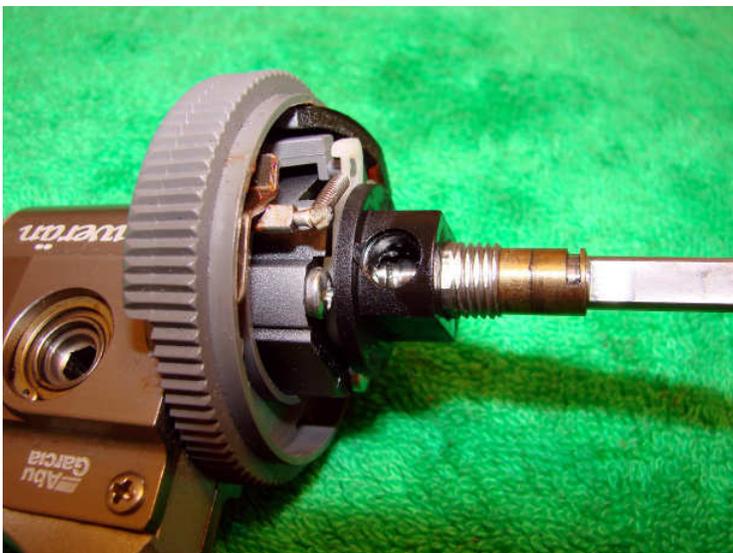
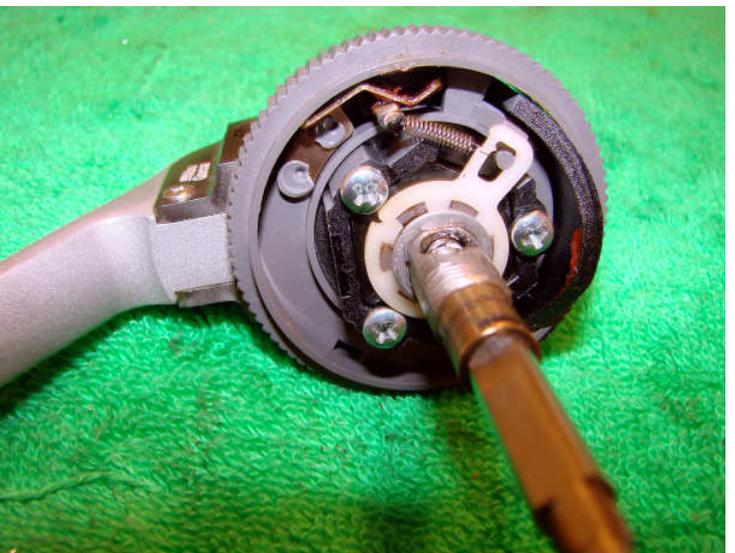
Undo the rotor nut and lift off the rotor.

This seems to be the problem with the lack of line lay-the pawl is missing completely. Remove the pawl holder and then remove the three screws holding the anti reverse selector to the body.

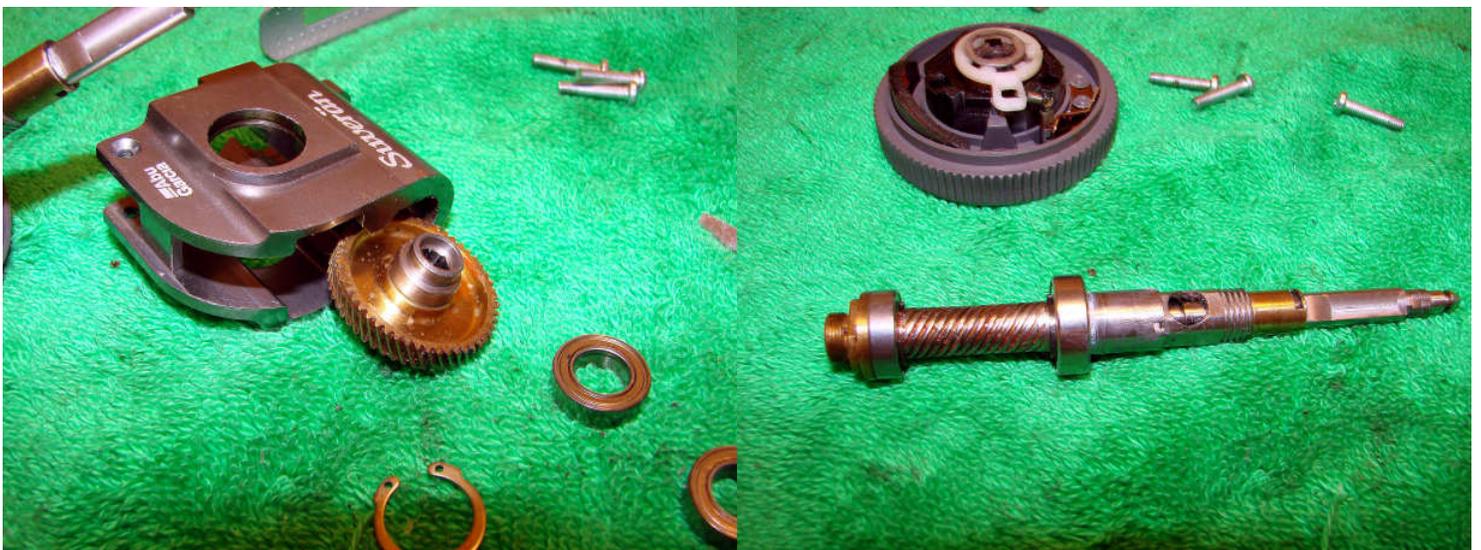
The reel body and the complete anti-reverse assembly can then be removed. Remove the bearing circlips.

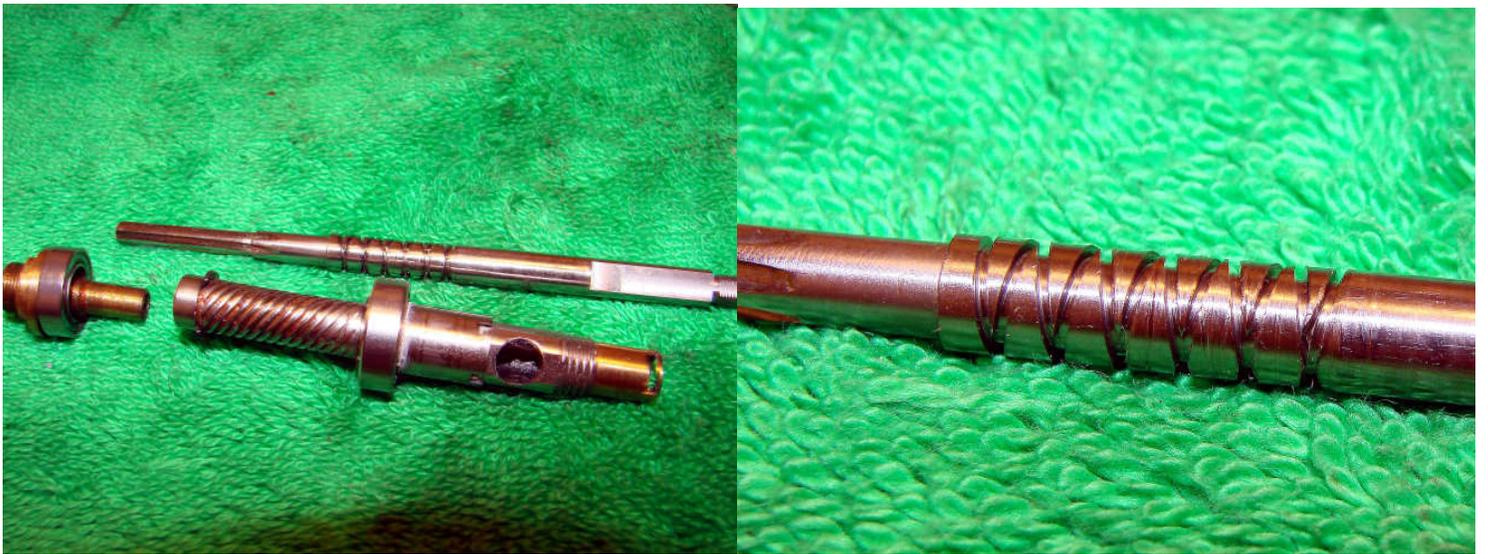
And then remove the bearings and main gear. The main shaft and pinion gear can then be removed.

Remove the main shaft from the pinion gear-note the damage to the worm gear on the main shaft (teeth on far right). It looks as though the pawl and worm gear were jammed at some stage-the pawl is the only part holding the main shaft in the body and it is likely that a combination of a heavy drag and low stretch braid caused this problem.

The worm gear can be touched up with a needle file and replacing the pawl assembly should have everything working again.

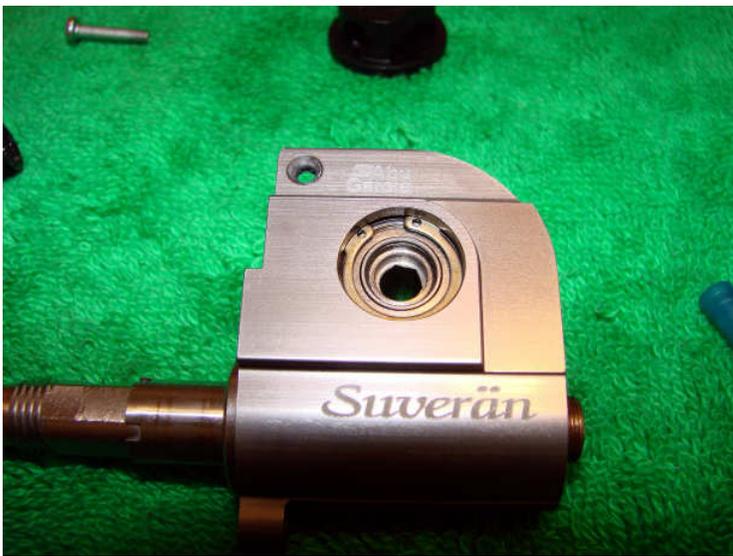
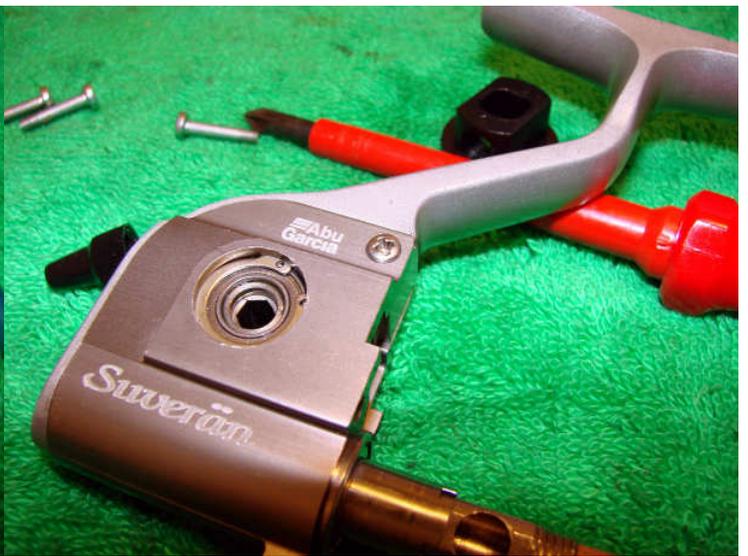
Clean and then lubricate all the bearings with a light grease (I use liquid grease). Grease the pinion gear and the main gear and then replace in the gearbox.

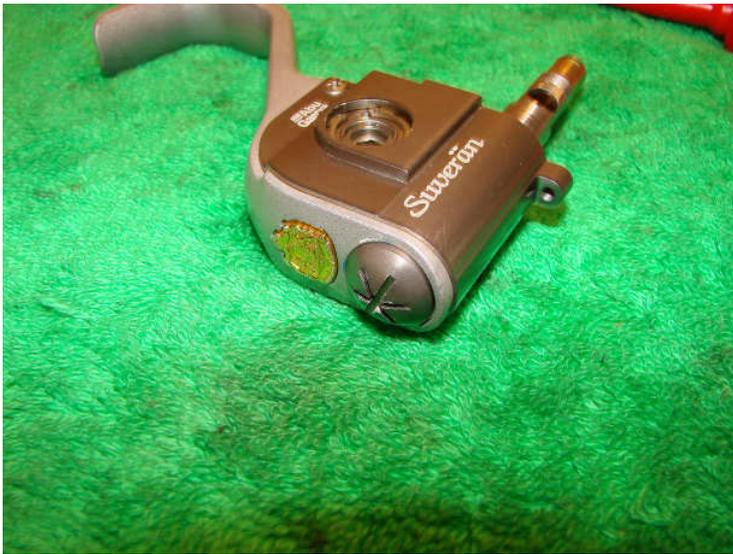
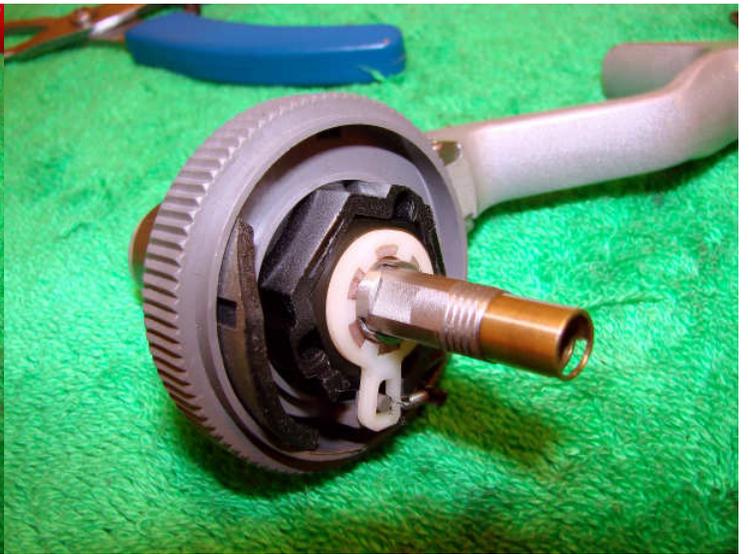
After cleaning and lubricating the bearings replace them in the gearbox and fix in place with the circlips. Replace the gearbox in the reel body and replace the two screws holding it in place.

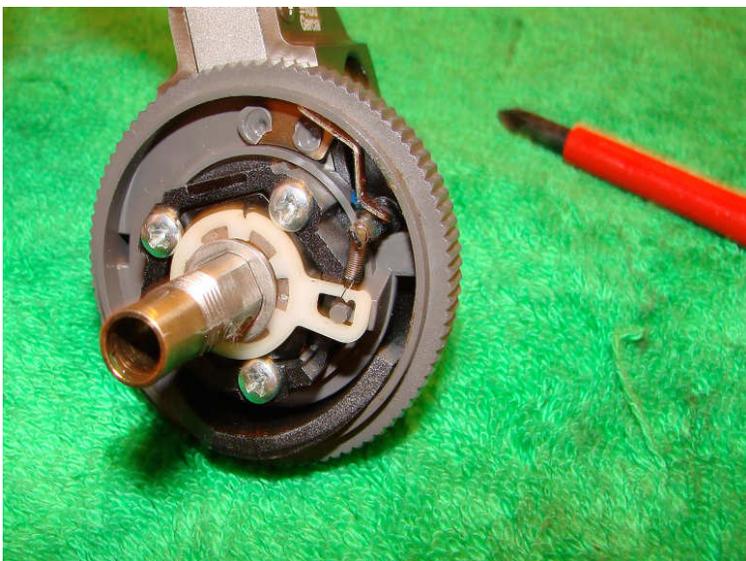
Grease the threads on the shaft nut and then replace. Replace the anti reverse assembly on the gearbox

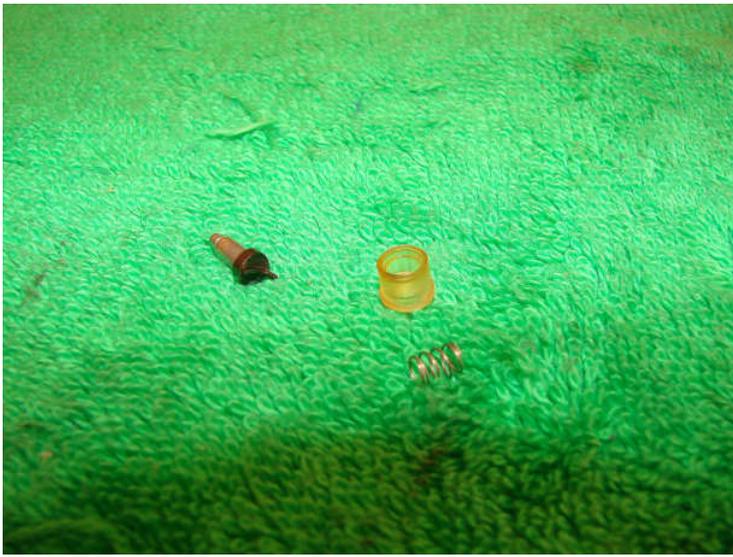
and replace the three screws to fix it in place.

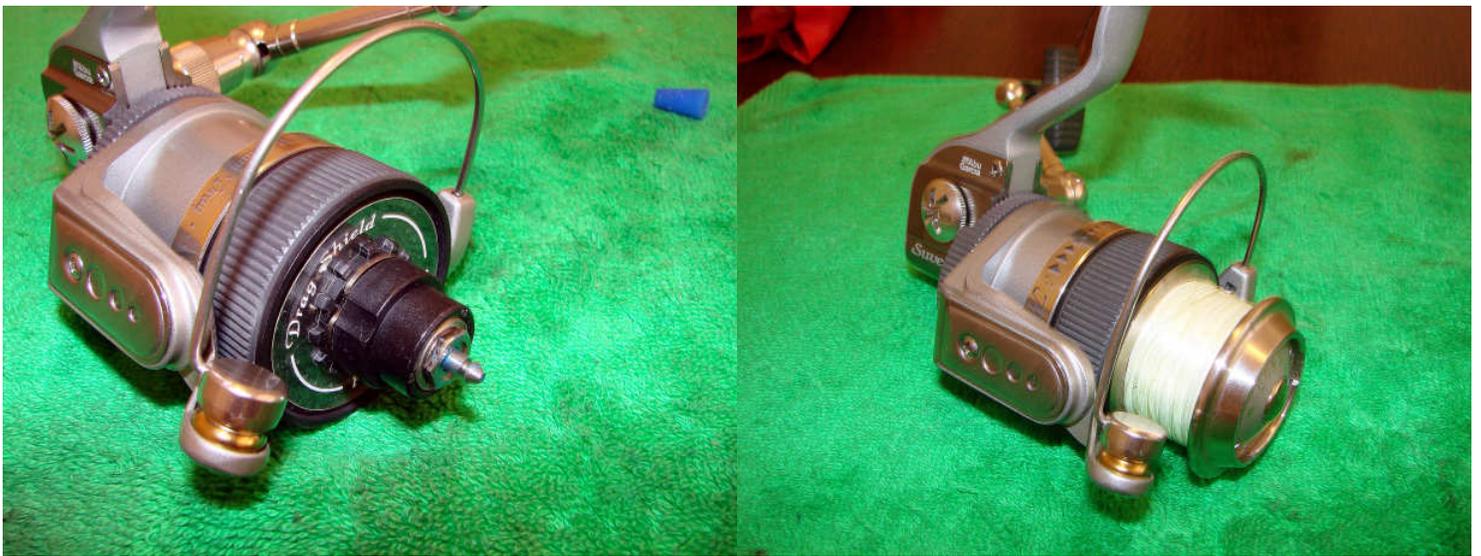
Separate out drag washers (left to right = bottom to top). Thoroughly clean the washers with a clean cloth soaked in lighter fluid. I don't have much faith in the drag shield and so I have greased the clean fiber washers with drag grease (Cal's drag grease). Replace the drag washers in the correct sequence and replace the upper spool bushing.

Replace the whole drag assembly back on the main shaft/rotor ensuring that it is seated properly.
