## Record Sport 2100 service

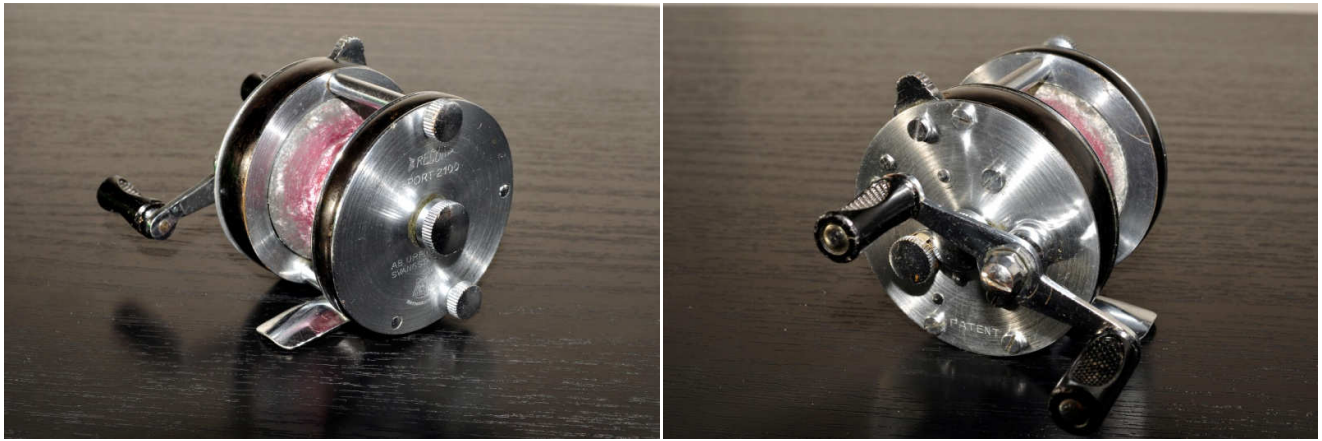
This reel seems to be working fine although the spool is showing some corrosion and salt deposits. The red colour could be colour bleeding from old dacron line.

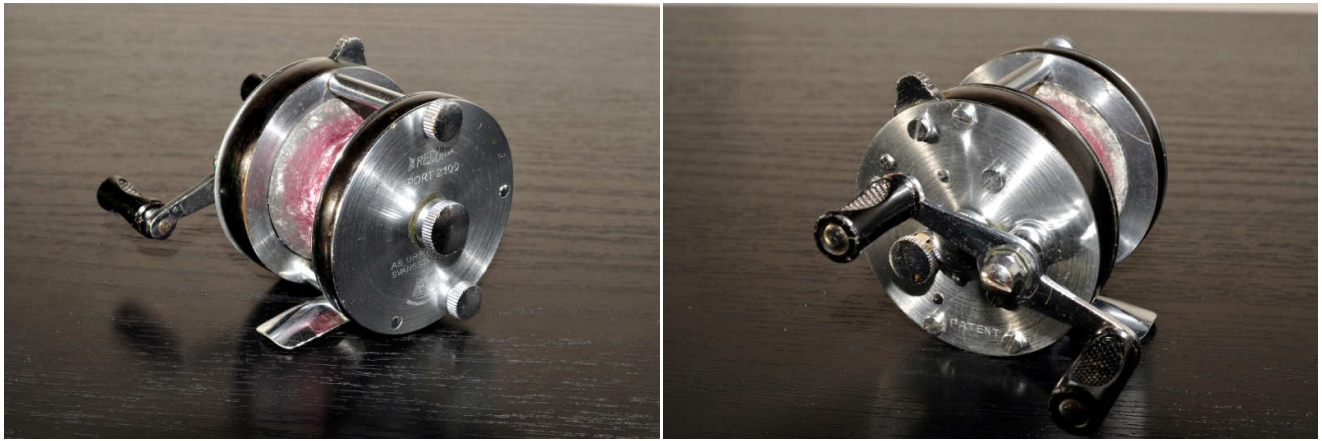
This reel seems to be working fine although the spool is showing some corrosion and salt deposits. The red colour could be colour bleeding from old dacron line.

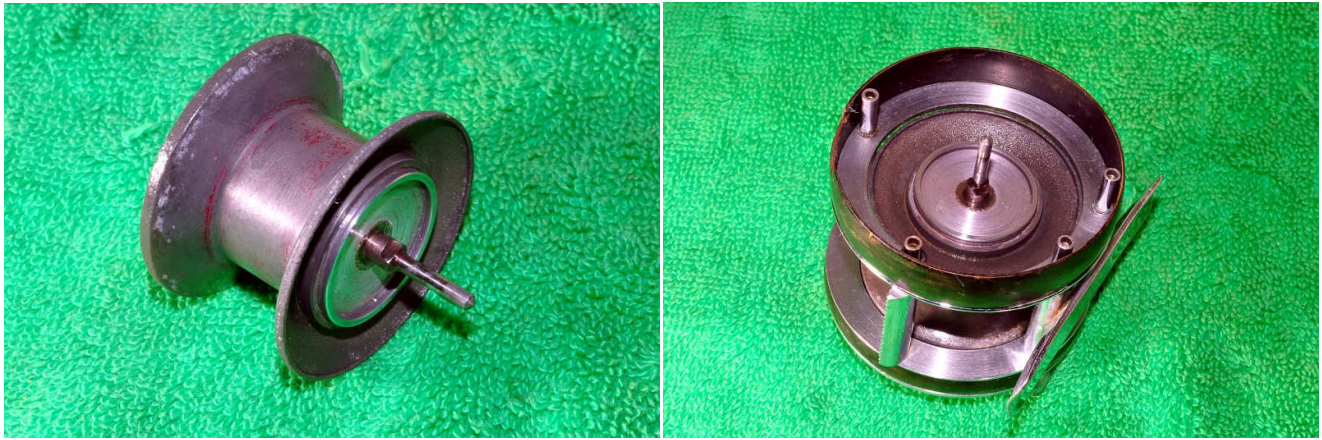
The spool has cleaned up nicely with some warm water and an old toothbrush. Add a drop of oil to the shaft at both ends and also where it contacts the pinion gear. Make sure that the centrifugal brakes are pushed in before replacing it in the frame. Note the metal ring on the spool where the felt washer contacts. This ring was not present in the ABU Sport 2100.

Replace the right side plate spacer and then replace the right side plate. Reaffix the handle and handle nut. Centre the spool in the frame with the spool caps-there should be a slight side to side movement.
